Miscellaneous Paper SL-94-1  
April 1994

## Efflorescence Study, Fort Leonard Wood, Missouri

by Tony B. Husbands

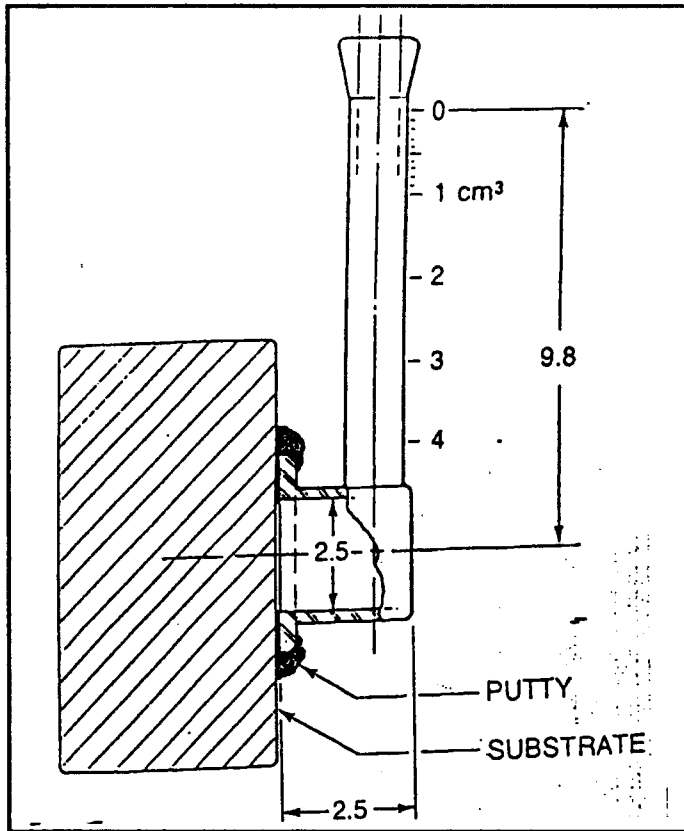
Figure 5. RILEM tube

Two test methods were selected for measuring water penetration the RILEM test and a method developed by the Construction Technology Laboratory (CTL). The RILEM test consists of the use of a graduated plastic cylinder that is mounted to a wall or test specimen by means of a putty. The apparatus is filled with water and the quantity of water entering the material during a specified period of time is read directly from the graduated tube. A RILEM tube with dimensions is shown in Figure 5. CTL's test apparatus consists of a 2-in.-diam chamber, which is attached to a wall. Two anchors were placed in a bed joint and two clamps were attached to the wall to firmly support the chamber against the wall. Putty was placed in front of a rubber gasket that sets around the chamber (Figure 6). Water was then pumped to the chamber until the chamber was filled as indicated by an overflow valve. Water was then forced into the wall under pressures ranging from 5 to 15 ps; 5 psi was selected for these tests. The amount of water penetration was then measured by a flow meter. A test in progress is shown in Figure 7.
